Field Jet Erosion Tests on the Mississippi River Collocated Demonstration Section, Plaquemines Parish, Louisiana

Johannes L. Wibowo, Perry A. Taylor, Bryant A. Robbins, and Eric W. Smith

June 2015

Final report

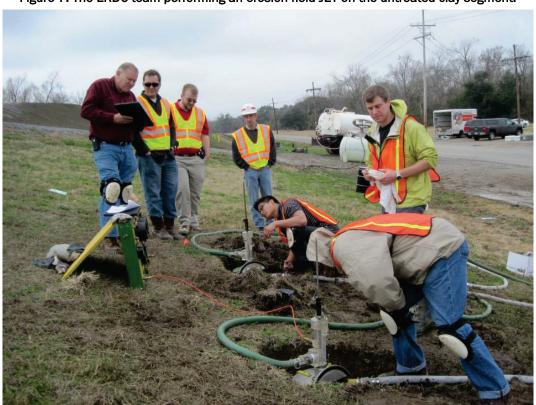
Figure 7. The ERDC team performing an erosion field JET on the untreated clay segment.

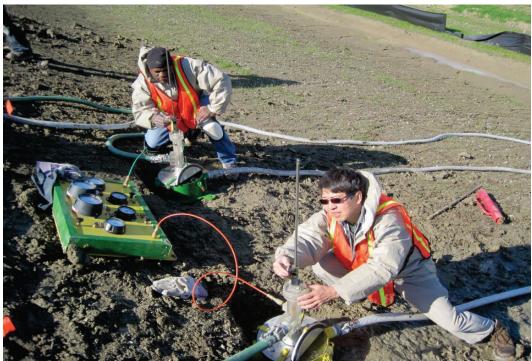
Figure 13. Test 5, clay segment with fly-ash/bed-ash treatment, (a) before and (b) after a field JET was performed.

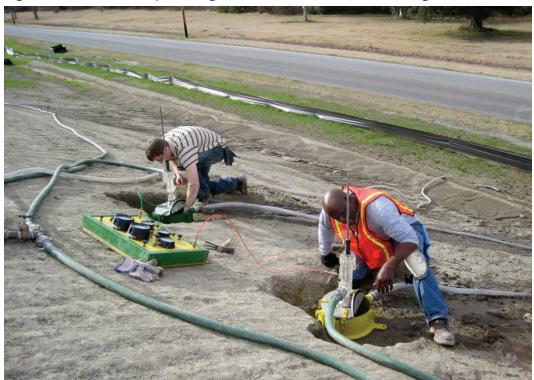
Figure 16. The ERDC team performing a field JET test on the lime-treated segment of the levee.

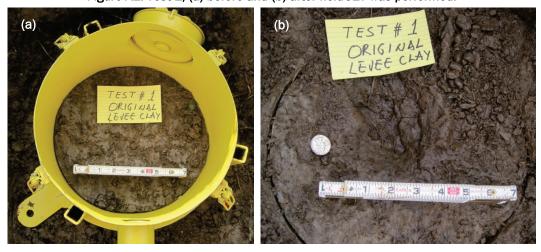
Figure A1. Test 1, (a) before and (b) after field JET was performed.

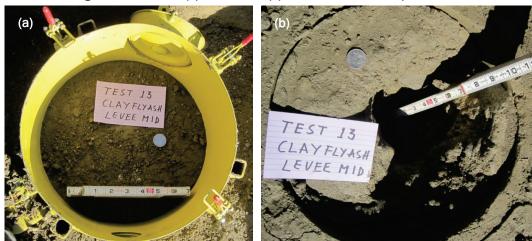
Figure B9. Test 13, (a) before and (b) after a field JET was performed.

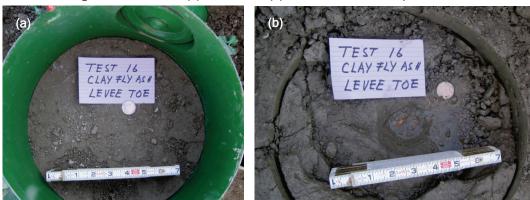
Figure B15. Test 16 (a) before and (b) after a field JET was performed.

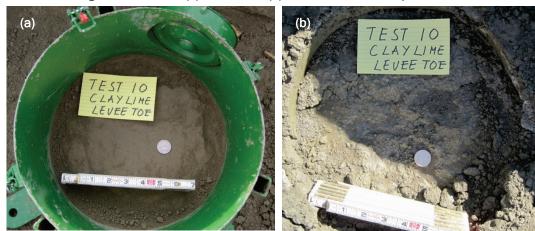
Figure C3. Test 10 (a) before and (b) after a field JET was performed.

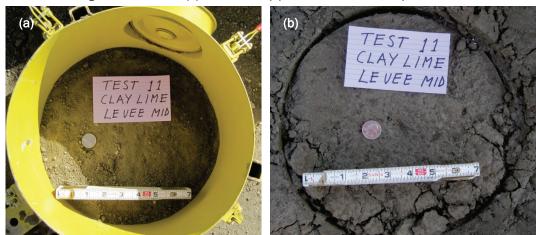
Figure C5. Test 11 (a) before and (b) after a field JET was performed.

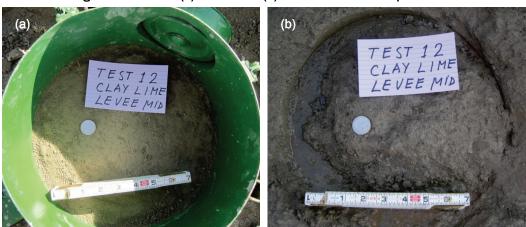
Figure C7. Test 12 (a) before and (b) after a field JET was performed.
